Property Visit Report

7 High Street, Hastings , East Sussex TN34 3EY

Report date: 4th April 2022

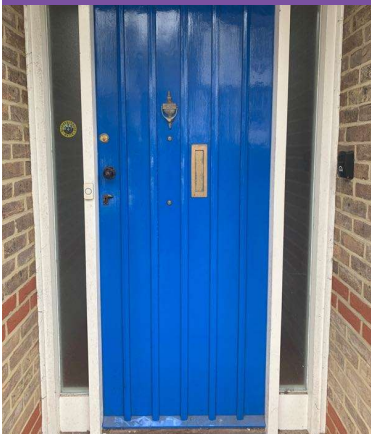
04-04-2022 11:43 / External Front Door / 14nrwrrly8

Roof and ridges, dormers, chimney	Good	Soffits and fascias	Good
Gutters / downpipes	OK	Front/back & patio doors	Good
		Photo code: 14nrwrrly8	
Windows, sills and frame	Good	Property walls	Good
Fencing, hedges & boundaries	Good	Lawn and borders	Fair
Trees and shrubs	Good	Steps, pathways and patios	Good
The tree has been removed			
Garage including door/roof	Good

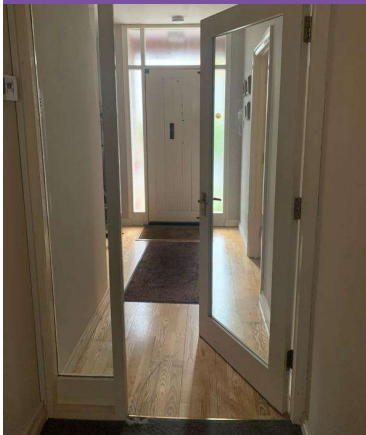
04-04-2022 12:02 / Woodwork Doors / Klrbh86t0

Walls and ceiling	Good	Flooring	Good
Woodwork and doors	Good		
Photo code: klrbh86t0

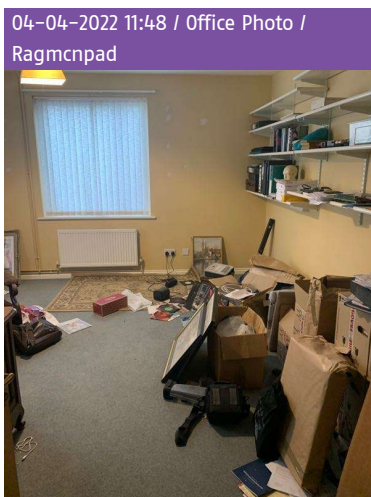
Walls and ceiling	Fair	Flooring	Good
As noted before this room needs redecorating			
Woodwork and doors	Good	Windows and sills	Good

The office room needs redecorating as they are white filler holes all over the room.

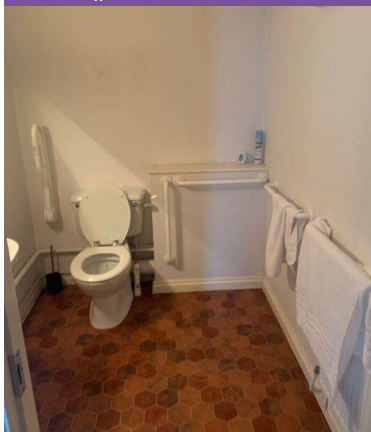
04-04-2022 11:48 / Toilet Photo / Vln7kmbqp

Walls and ceiling	Good	Flooring	Good
Slight marking to the wall.			
Woodwork and doors	Good	Sanitary ware	Good
Light and electrical fittings	Good	Leaks or leak damage	No

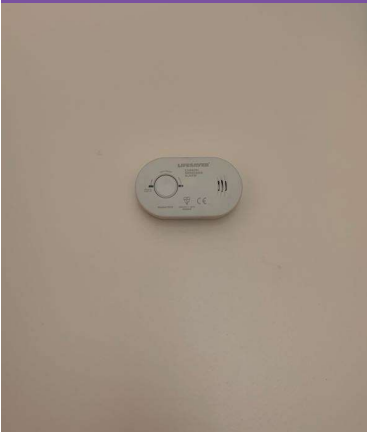
04-04-2022 11:50 / Carbon Monoxide Detector / 8do13avz

Expires 22-02-2023 in the utility room where boiler is kept.

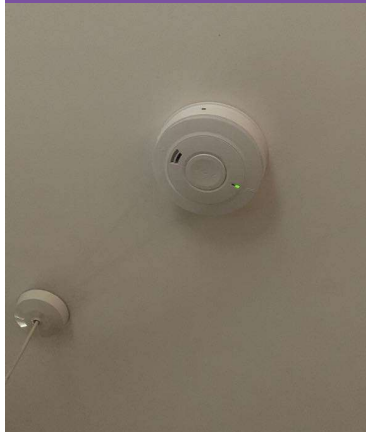
04-04-2022 11:55 / Smoke Detector Floor1 / 97xjd9n7i

In the hallway - expires 1-1-2027

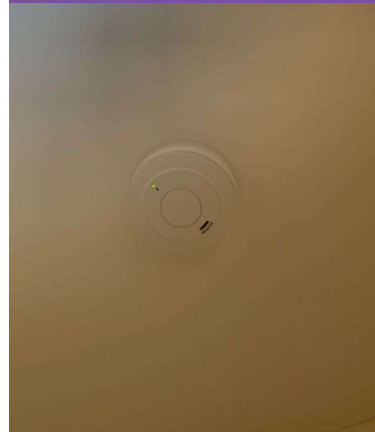
04-04-2022 12:02 / Smoke Detector Floor2 / Ko4eggjch

In the hallway at the top of stairs - expires 1-1-2027.

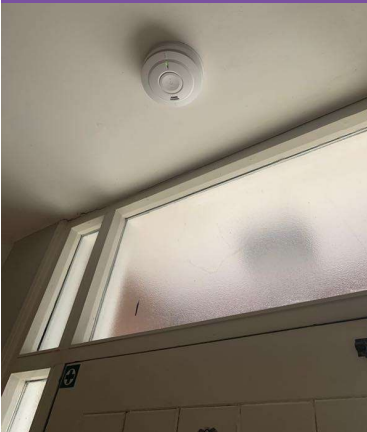
04-04-2022 12:04 / Smoke Detector Floor1 / Yq3o5v606

In the hallway by the front door expires 1-1-2027
