Property Visit Report

7 High Street, Hastings , East Sussex TN34 3EY

Report date: 4th April 2022

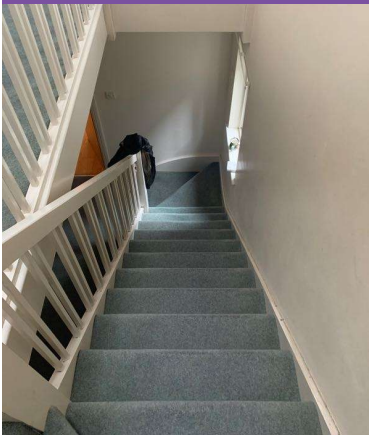
04-04-2022 12:02 / Entrance And Hallway Photo / M9ibe317r

Walls and ceiling	Good	Flooring	Good
Woodwork and doors	Good		
Photo code: klrbh86t0

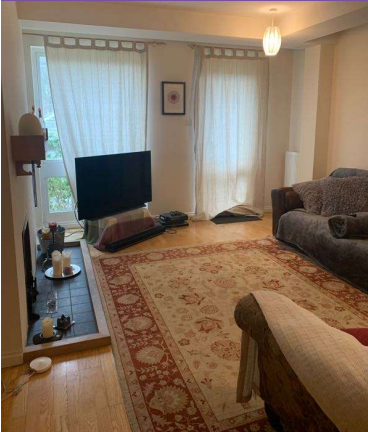
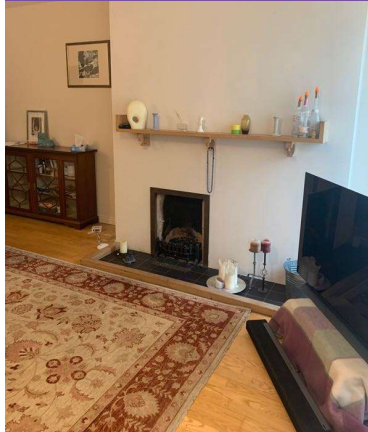
04-04-2022 11:46 / Lounge Photo / Z0tmlg9jc

Light and electrical fittings	Good	Leaks or leak damage?	No
Heating	Good	Mould or damp?	No
Tenant does not use fire			
Natural lighting?	Good	Room layout - is it safe / fit for purpose?	Good

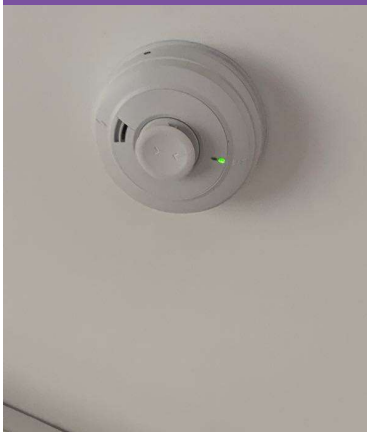
04-04-2022 11:52 / Kitchen Photo / 15t4fcl91

In the kitchen - expires 1-1-2027

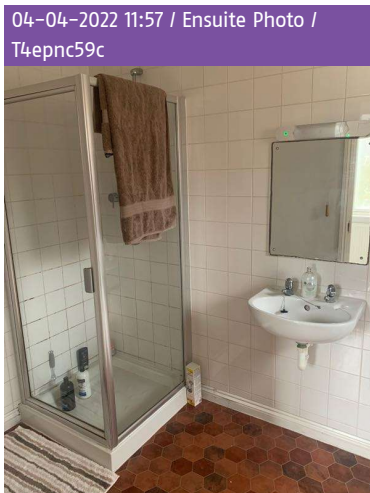
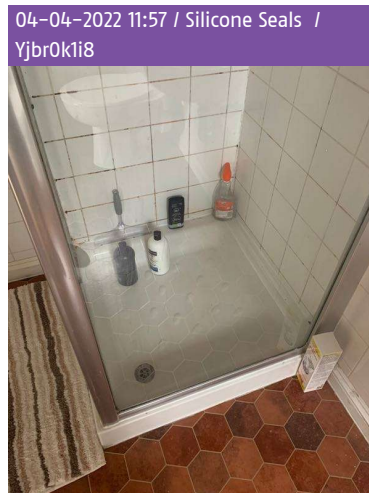
Walls and ceiling	Good	Flooring	Good
Woodwork and doors	Good	Windows and sills	Good
Sanitary ware	Good	Shower and attachments	Good
Silicone seals	Good	Tiles and grout	Fair
Photo code: yjbr0kli8			
Extractor fan	Good	Light and electrical fittings	Good
Leaks or leak damage	No	Heating	Good
